Automotive Engine Head 3D Inspection

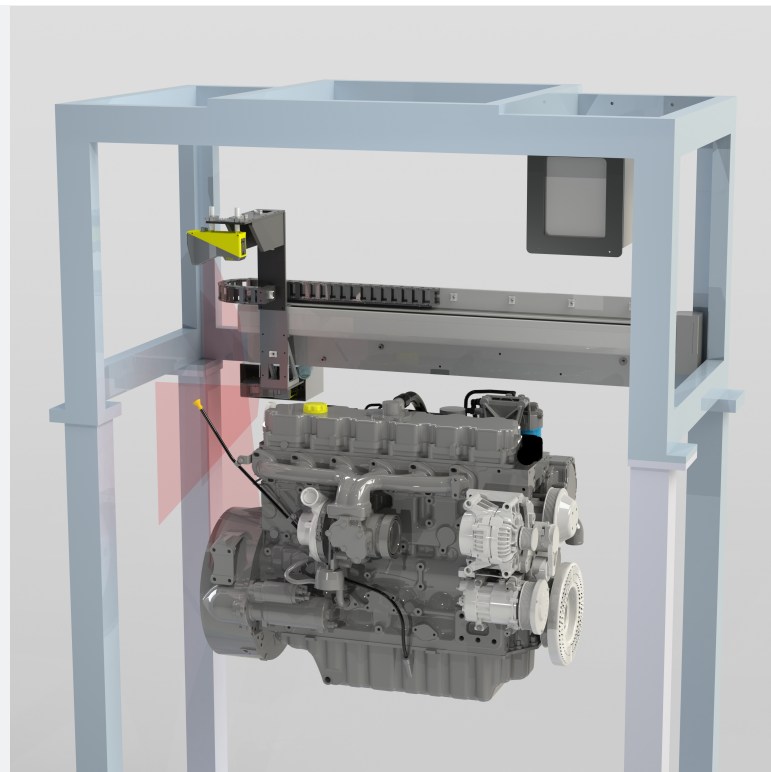
This system utilizes two Cognex DS (displacement sensor camera) 3D units in conjunction with a Yamaha single axis linear servo. The Yamaha linear servo carries the two DS units across the scanning plane. The inspection system images the upper assembled head of the engine block at different angles to verify items such as valve positioning, rocker arm set screw height, and various presence/absence inspections.

Application inspects for debris in specific portions of the engine head, presence/absence of the Push Tube, Rocker Arms, Cross Foot, Set Screws and Jake Brake if applicable. The application also measures the height of the set screws and determines if they are within a specified tolerance. This type of application setup could be used to inspect anything that requires inspection at 90° angles from each other. Parts per minute rate of this application is dependent on the customer line speed rather than the capability of the inspection system. The inspection system is capable of approximately 4 parts per minute at the current inspection settings where the customer line rate is 1 part per 2-5 minutes on average.
